NIST NCSTAR 1-5A

Federal Building and Fire Safety Investigation of the World Trade Center Disaster

Visual Evidence, Damage Estimates, And Timeline Analysis

(Chapter 9 - Appendix C)

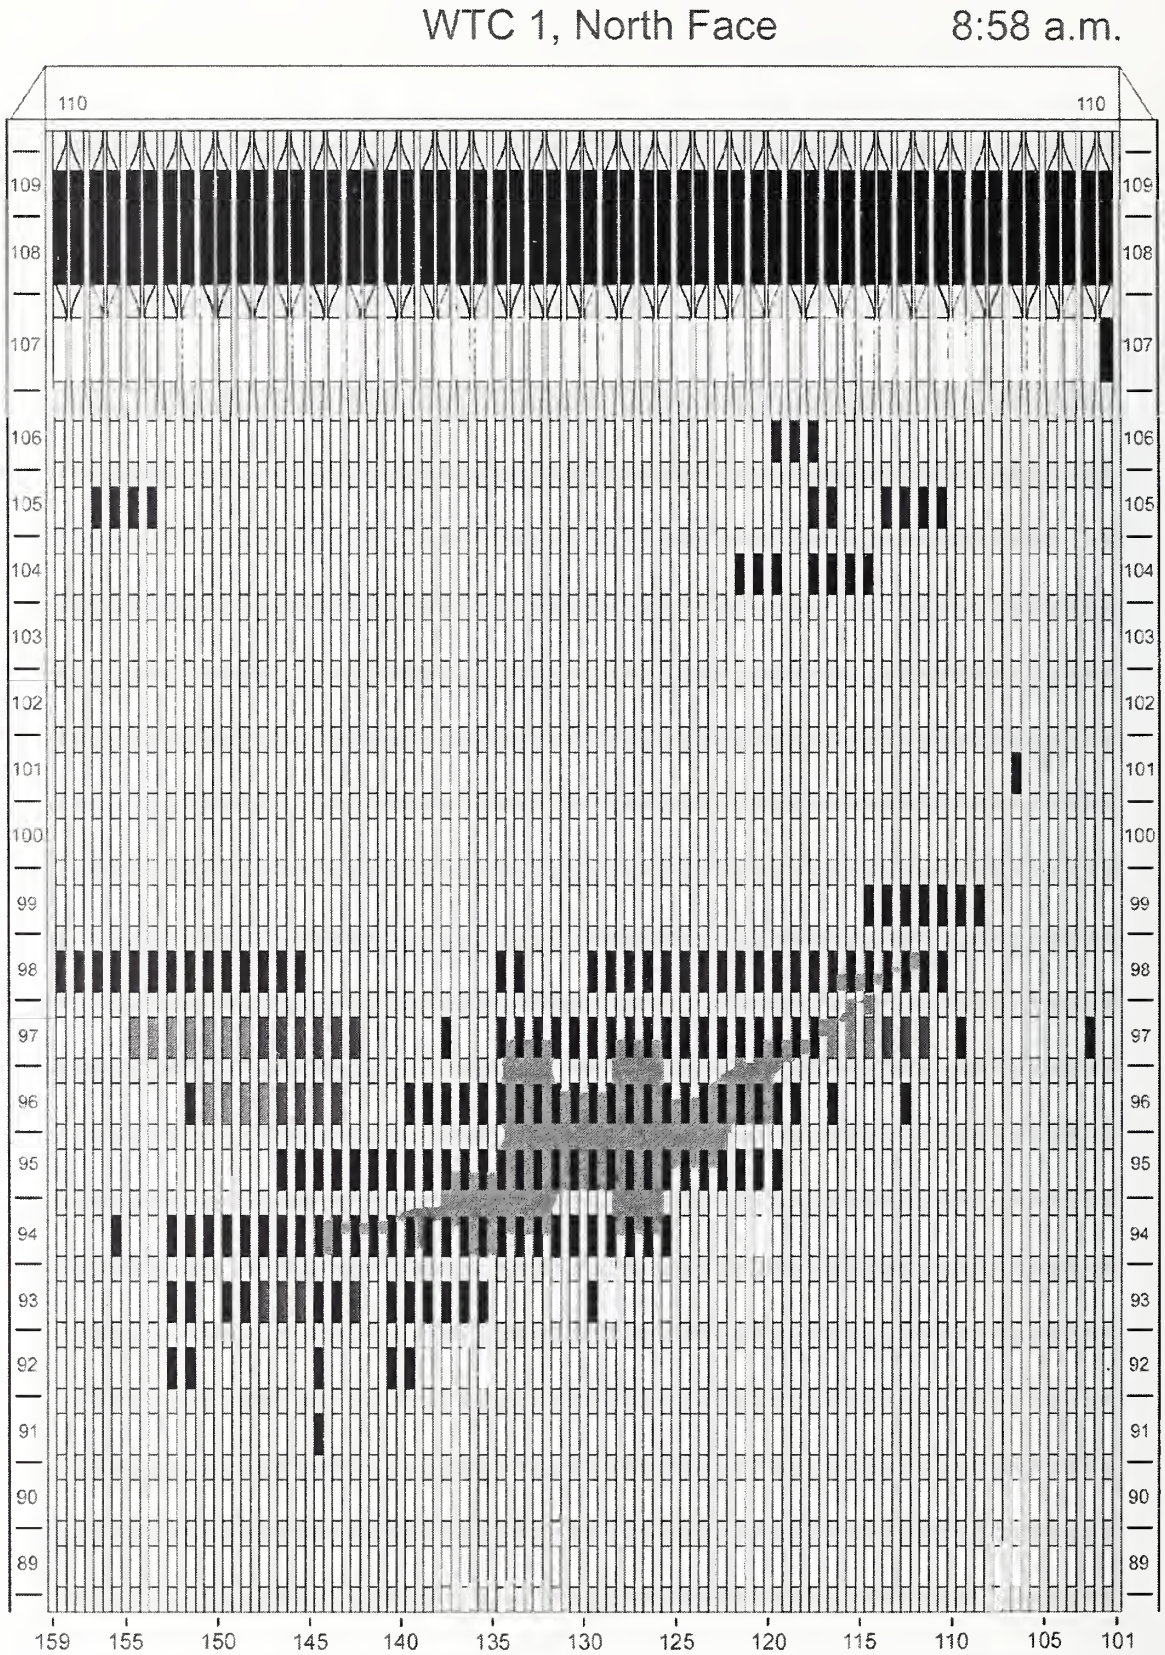
Figure C-13. Diagram of the north face of WTC 1 for floors 89 to 110 at 8:58 a.m. showing the condition of windows and locations of fires.

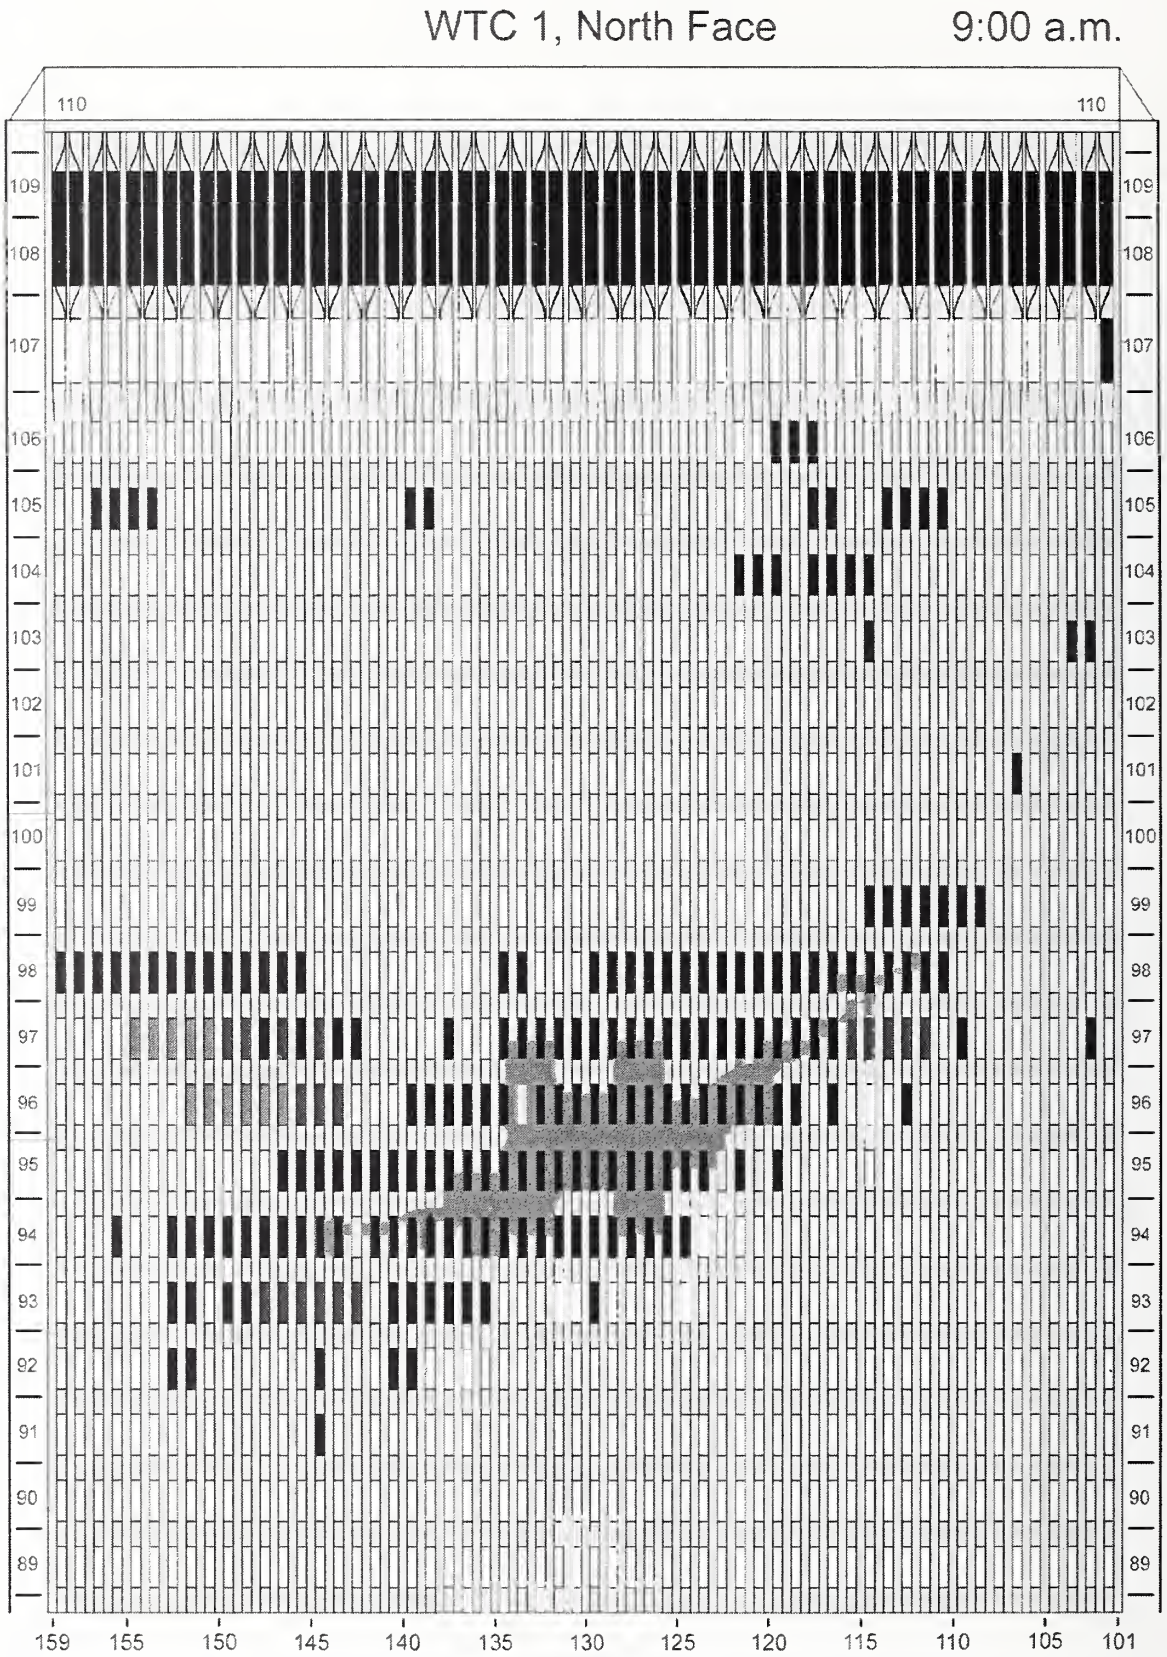
Figure C-15. Diagram of the north face of WTC 1 for floors 89 to 110 at 9:00 a.m. showing the condition of windows and locations of fires.

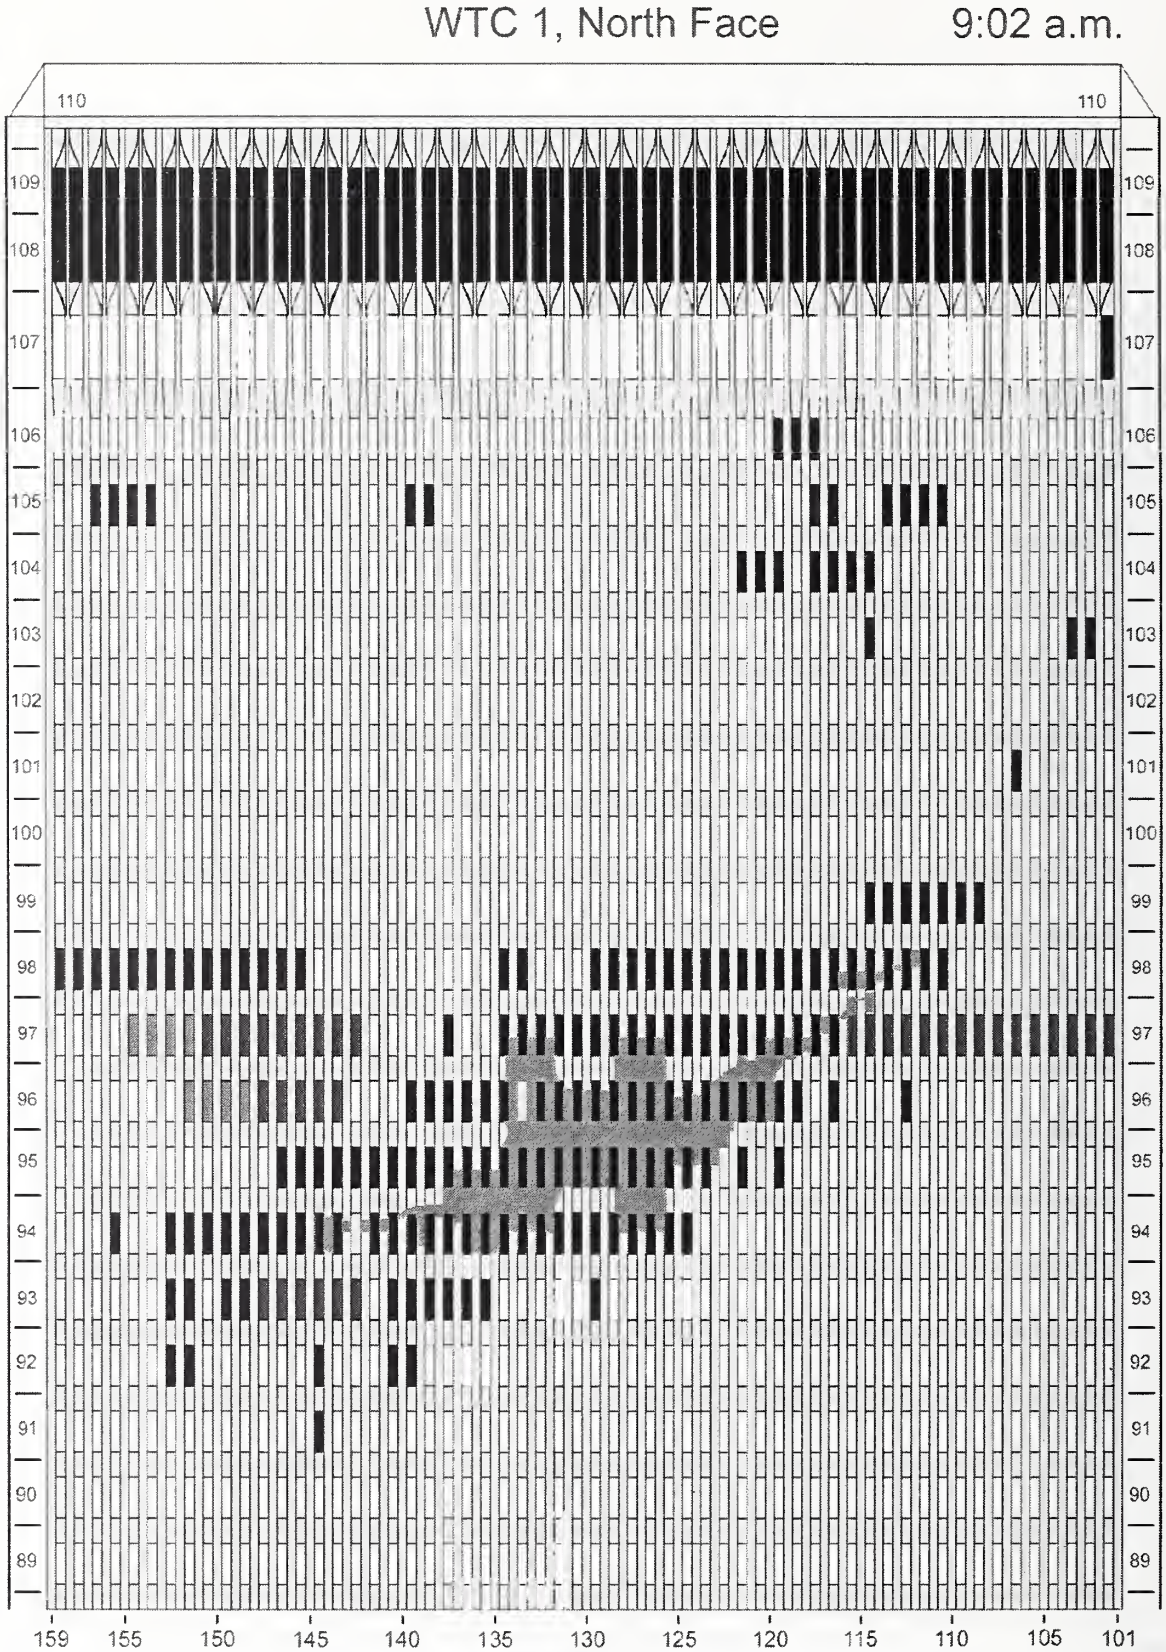
Figure C-17. Diagram of the north face of WTC 1 for floors 89 to 110 at 9:02 a.m. showing the condition of windows and locations of fires.

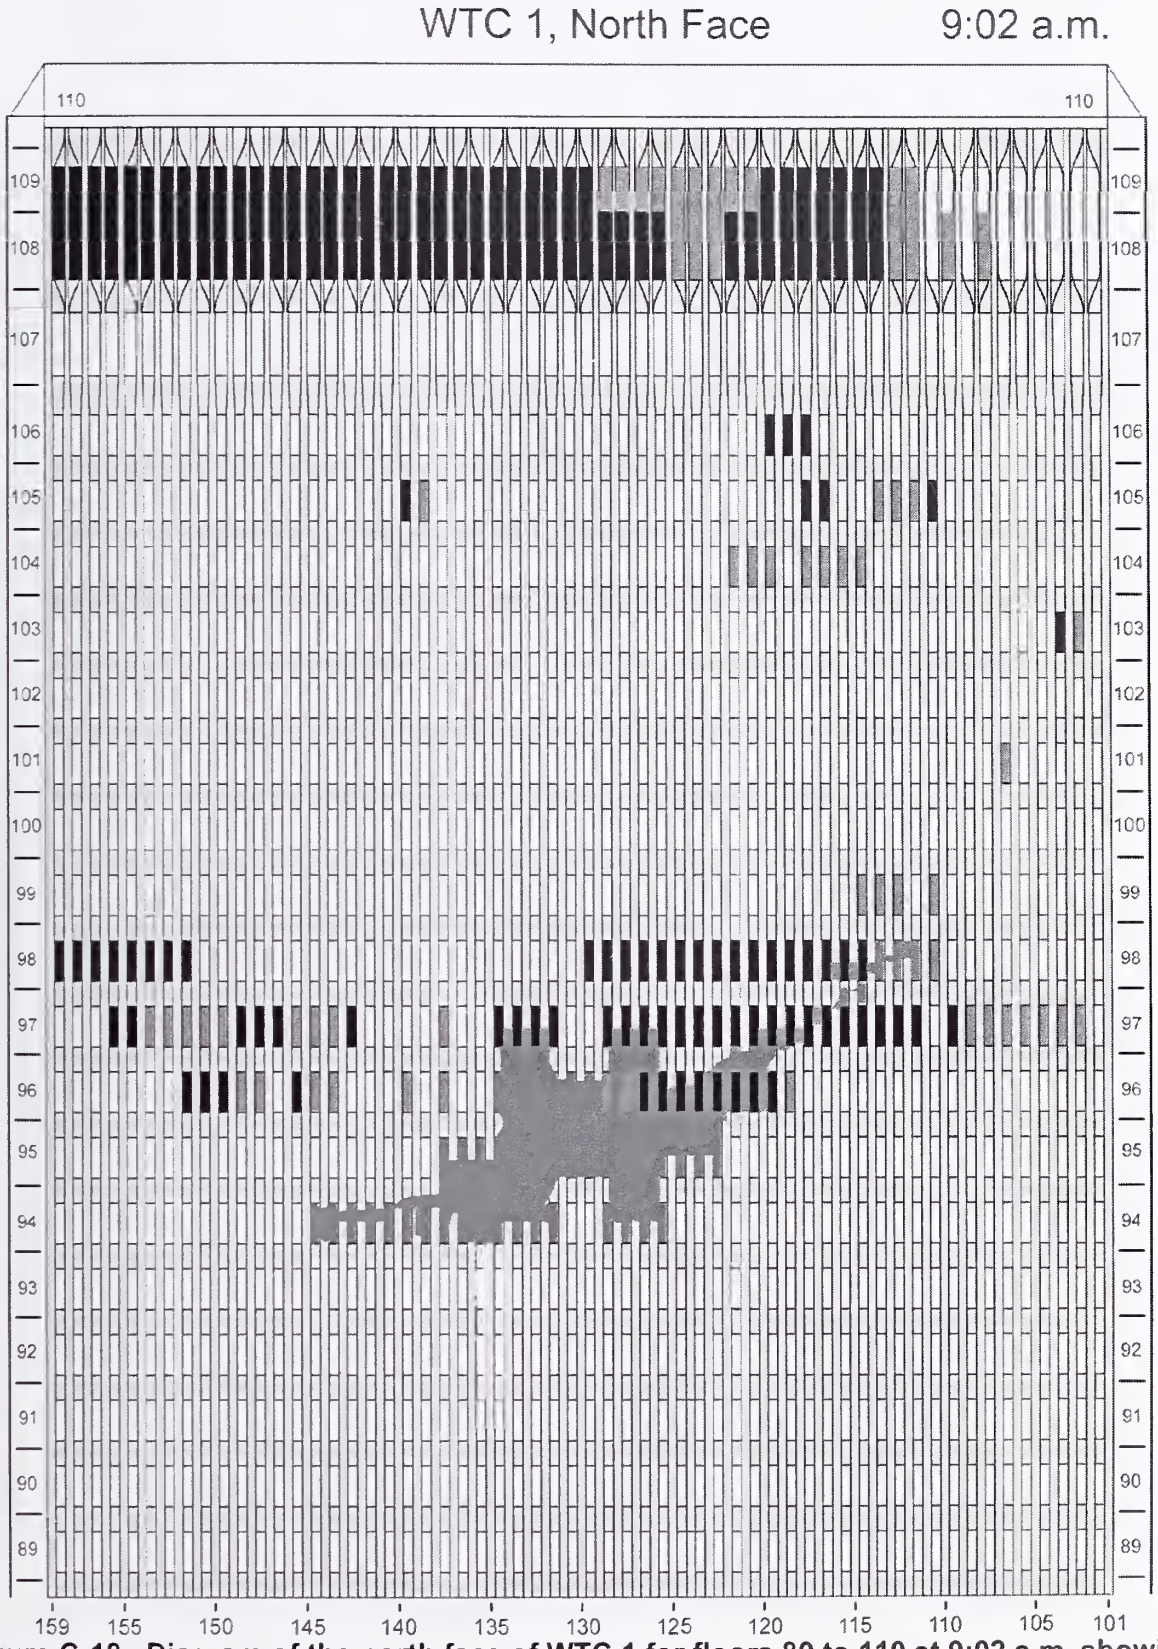
Figure C-18. Diagram of the north face of WTC 1 for floors 89 to 110 at 9:02 a.m. showing windows where smoke was observed and those that were hidden from view.

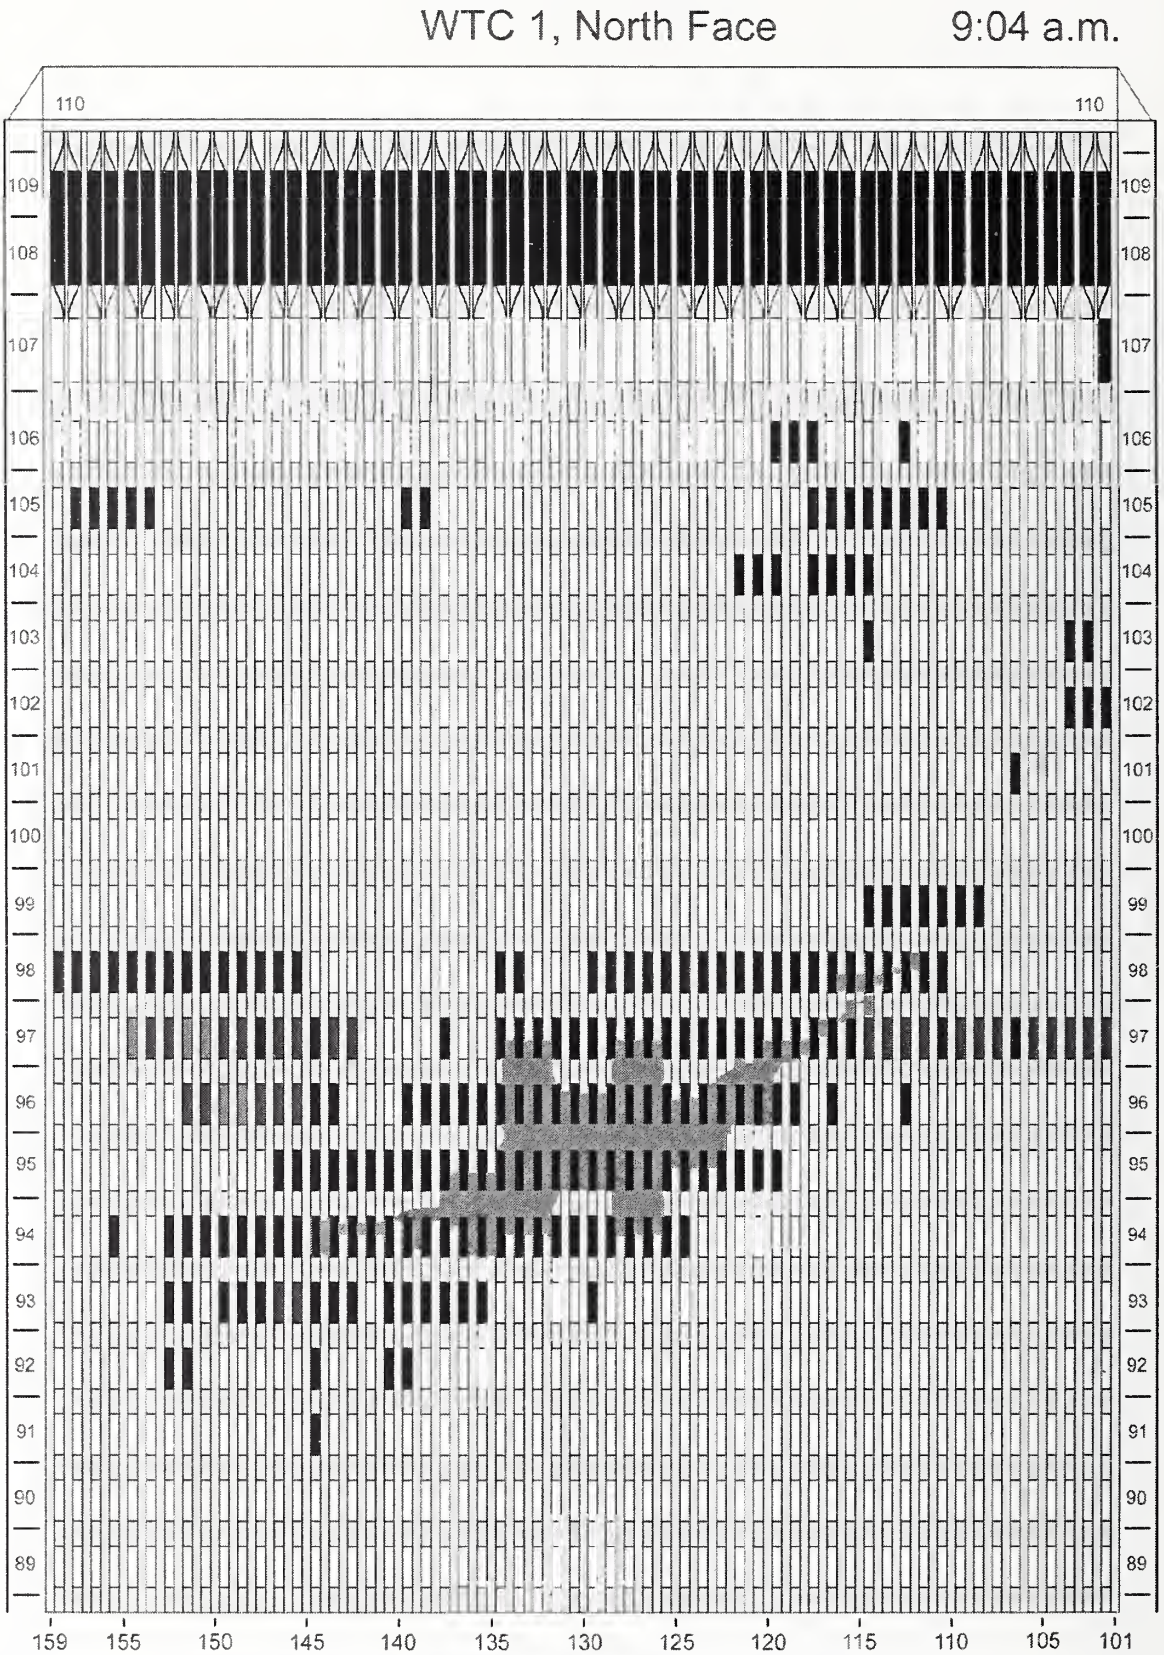
Figure C-19. Diagram of the north face of WTC 1 for floors 89 to 110 at 9:04 a.m. showing the condition of windows and locations of fires.

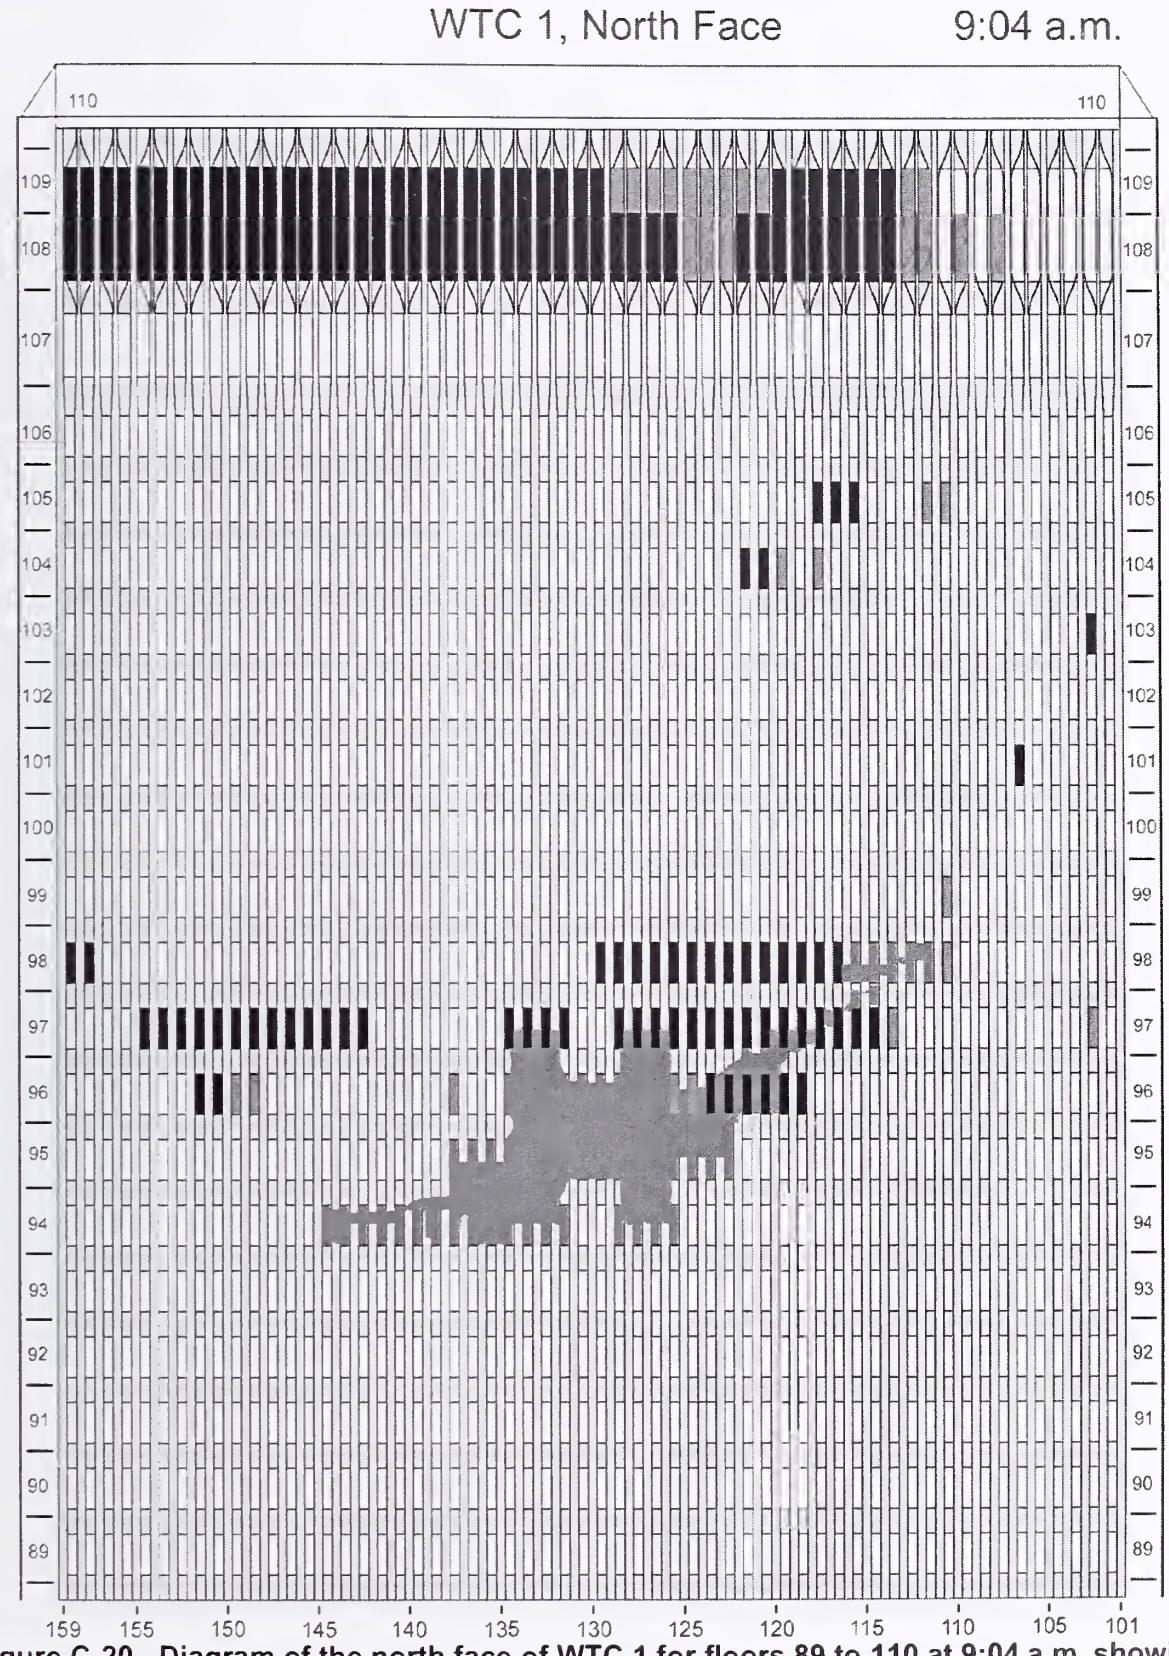
Figure C-20. Diagram of the north face of WTC 1 for floors 89 to 110 at 9:04 a.m. showing windows where smoke was observed and those that were hidden from view.

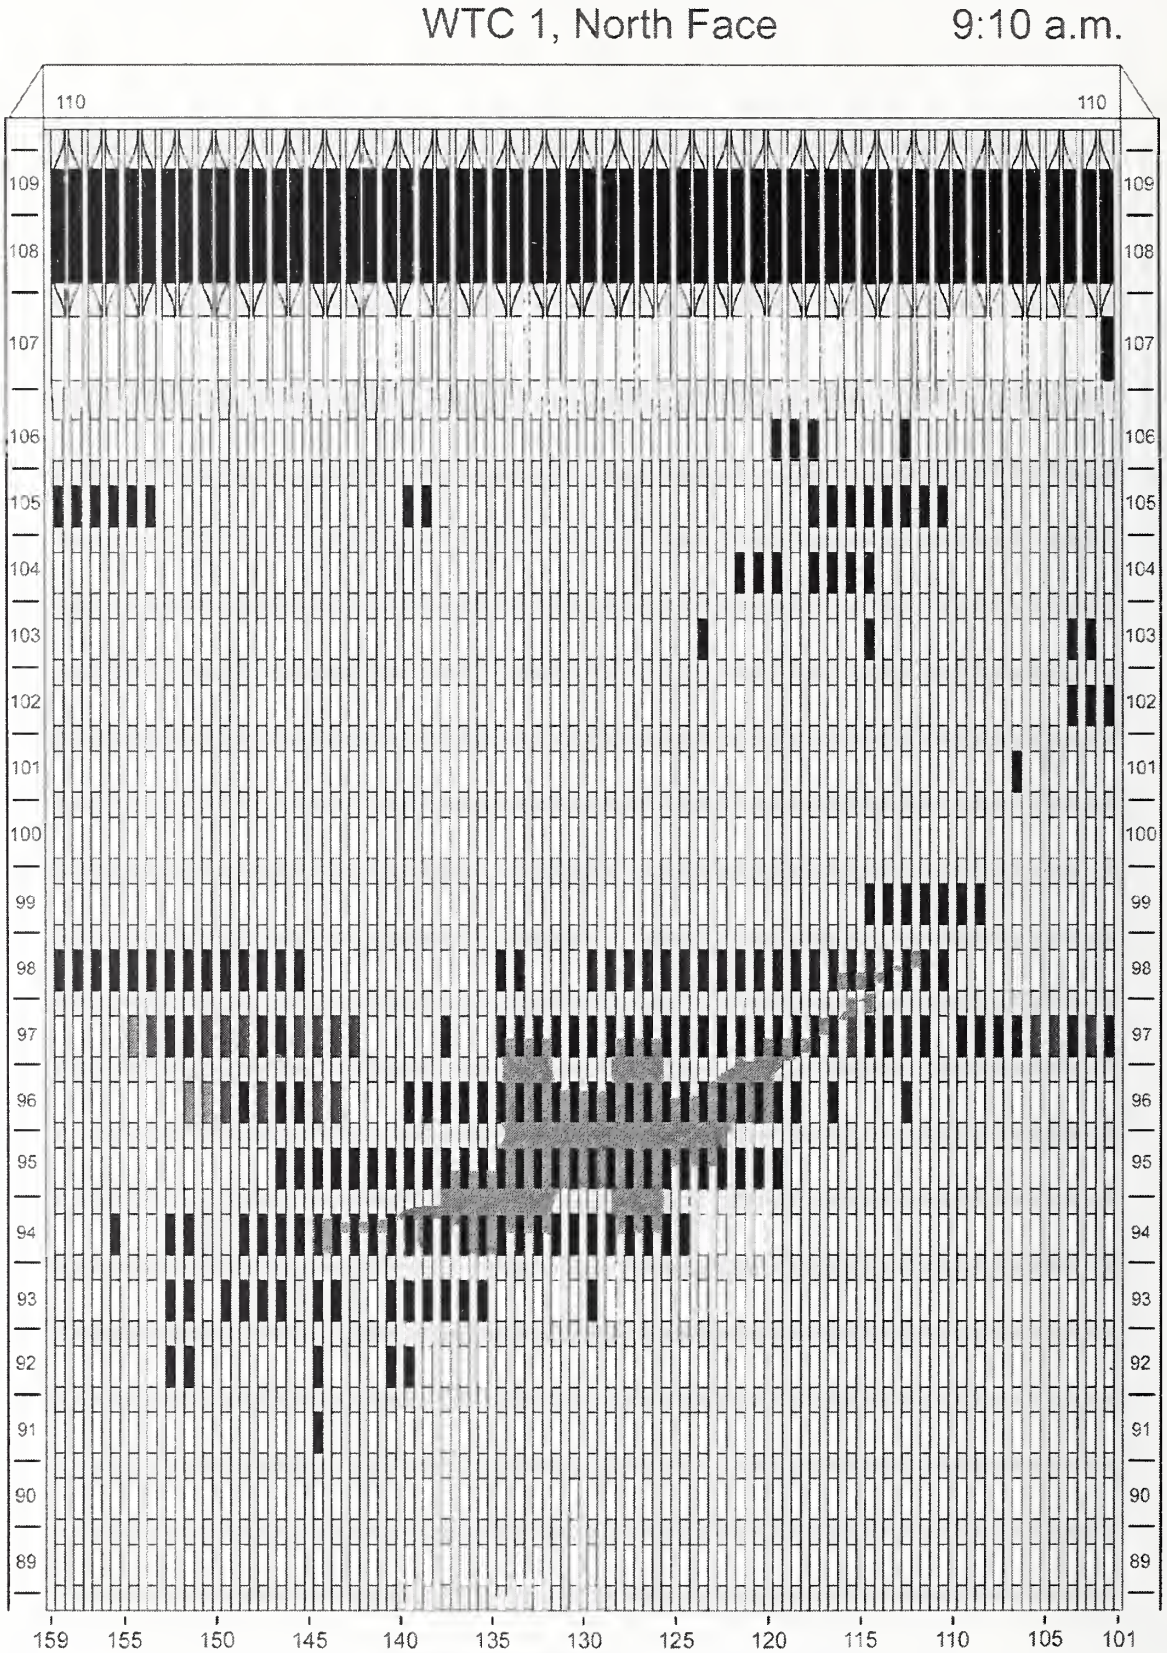
Figure C-21. Diagram of the north face of WTC 1 for floors 89 to 110 at 9:10 a.m. showing the condition of windows and locations of fires.

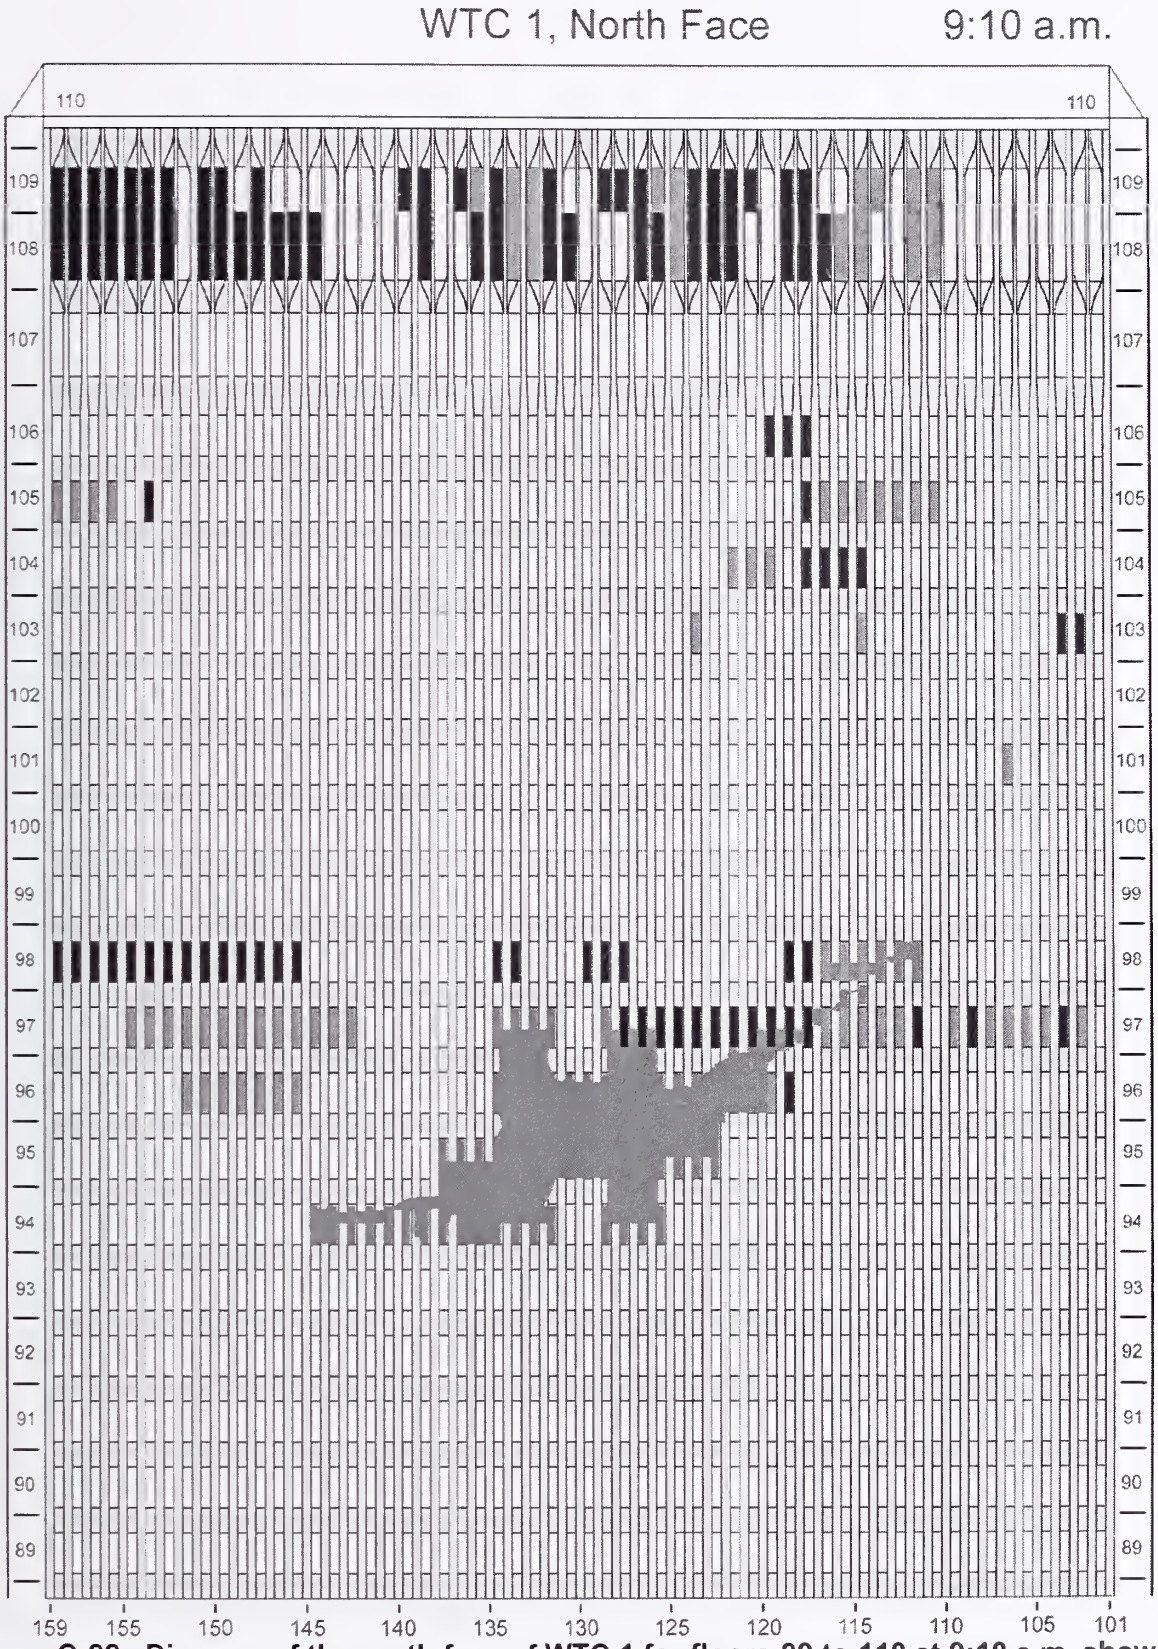
Figure C-22. Diagram of the north face of WTC 1 for floors 89 to 110 at 9:10 a.m. showing windows where smoke was observed and those that were hidden from view.

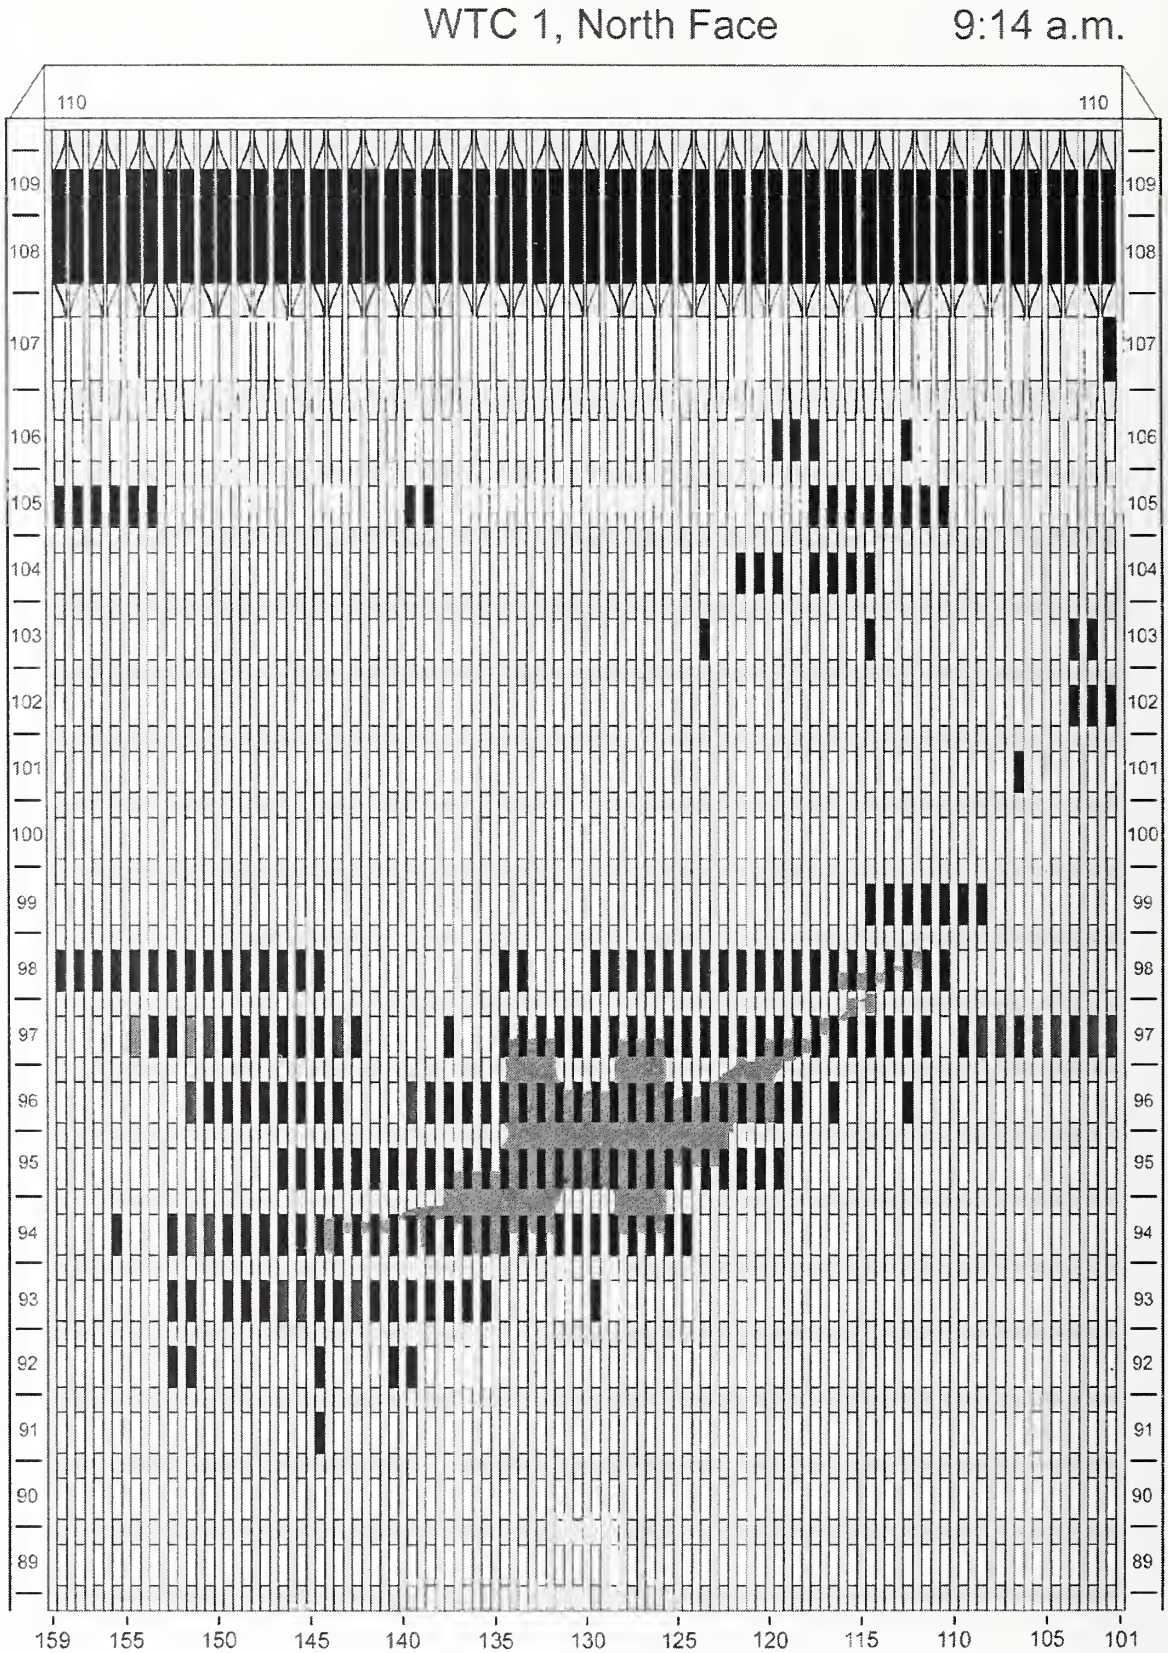
Figure C-23. Diagram of the north face of WTC 1 for floors 89 to 110 at 9:14 a.m. showing the condition of windows and locations of fires.

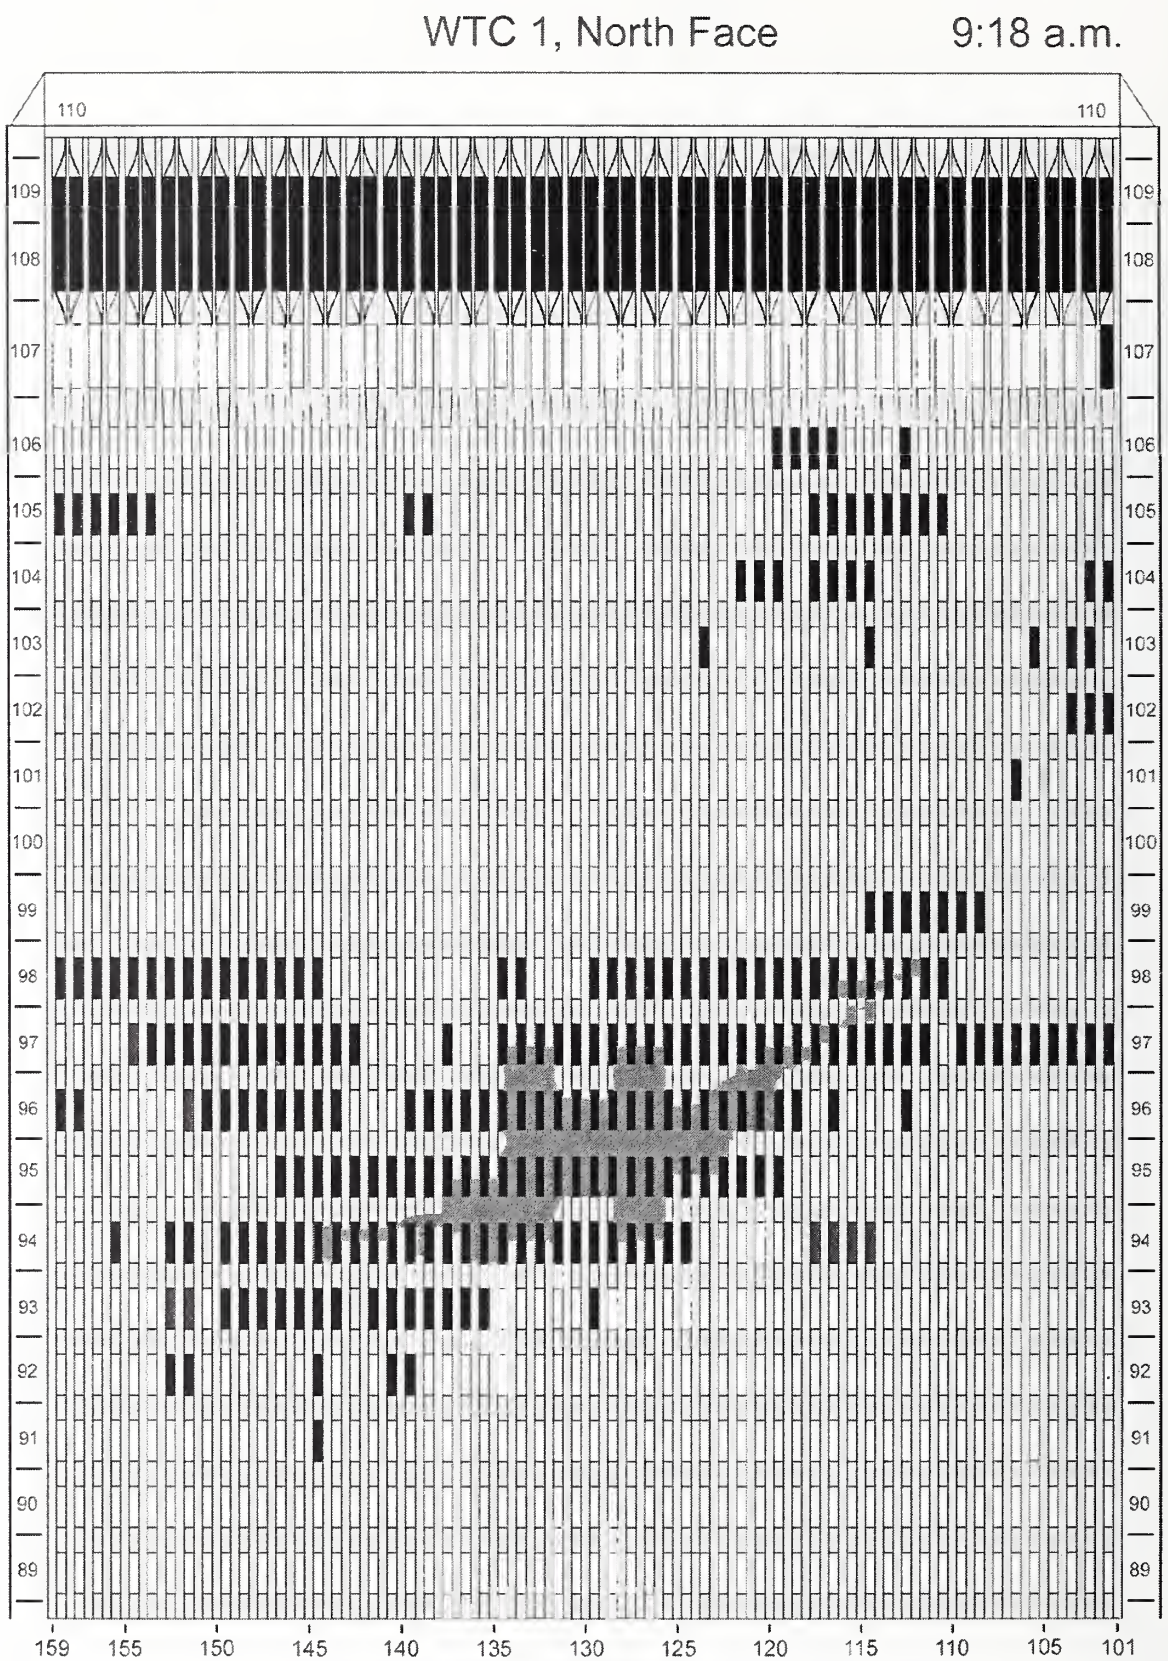
Figure C-25. Diagram of the north face of WTC 1 for floors 89 to 110 at 9:18 a.m. showing the condition of windows and locations of fires.

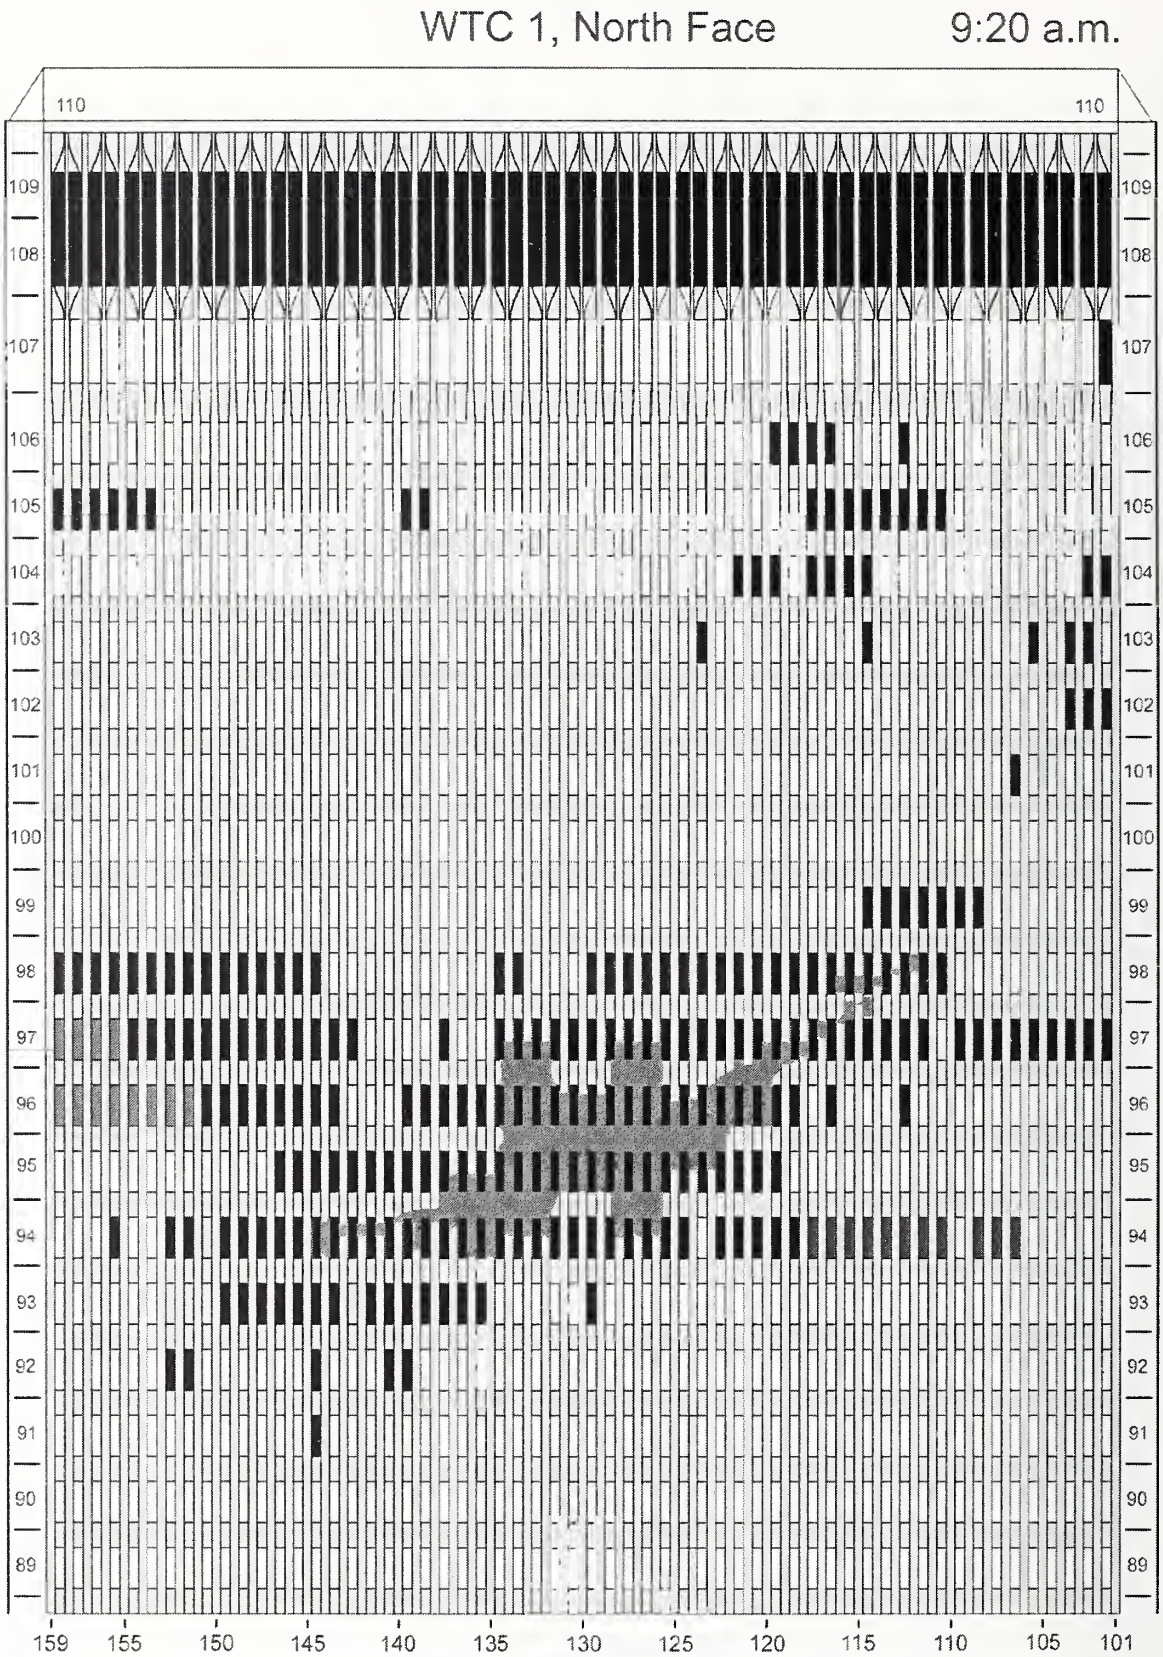
Figure C-27. Diagram of the north face of WTC 1 for floors 89 to 110 at 9:20 a.m. showing the condition of windows and locations of fires.
